Application Note

High-resolution SPM measurements of injection-moulded plastic parts

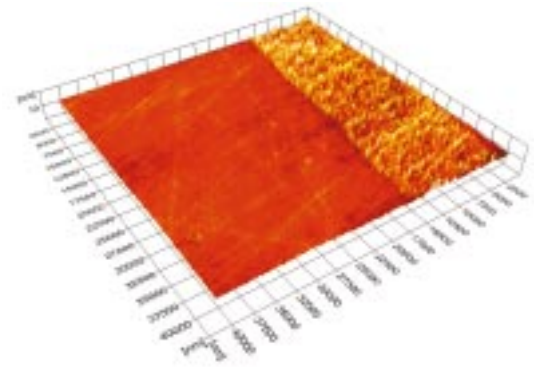
Fig.: 3D NANOSTation II image

Thanks to the use of the *NANOSTation II* scanning probe microscope from S.I.S., it was discovered that the streaks are a rough (spiky) coating. The illustration on the left shows a 2D image of the transition from streaks (right) to the smooth surface (left) as well as a profile section through both areas. The original smooth surface is rough and uneven. The plastic stuck to the mould at these points, producing these miniature peaks during removal from the mould. Thus, the streaks are not a coating on the mould, but the adhesive effect of the plastic to the mould. This could only be detected by the use of a scanning probe microscope (SPM).
